Factors contributing to the life time performance of flat roofing with polymer membranes

Experience and knowledge accumulated during more than 30 years (from 1985 until 2017) of conducting analyses on more than 200 construction projects.

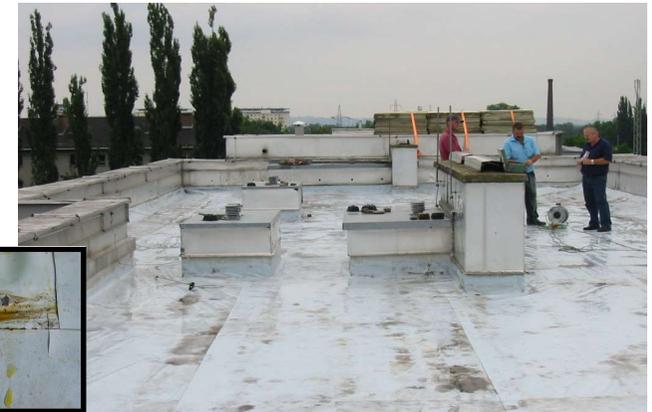
leaky
after
13
Years

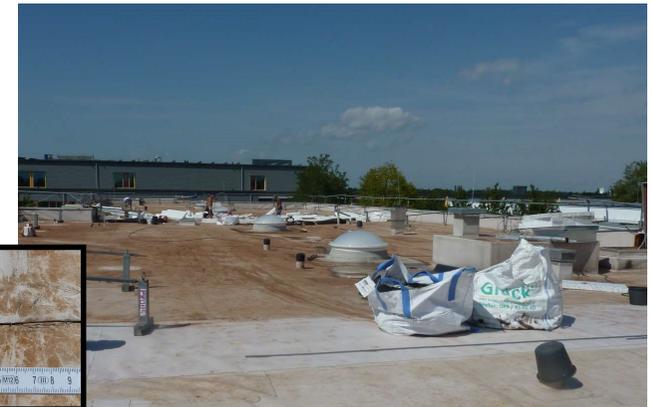
leaky
after
16
Years

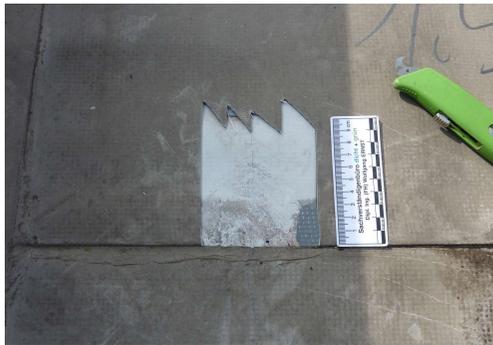
Faulty manual weld at the end of the automatic weld.

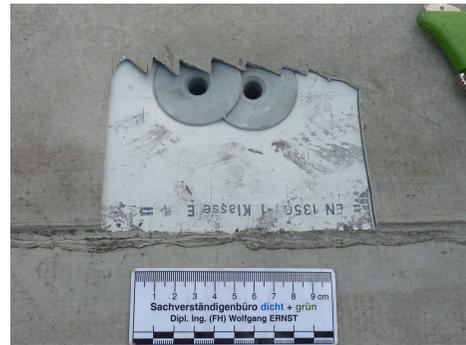
Rupture of the seam welding caused by withdrawal of the welding nozzle.

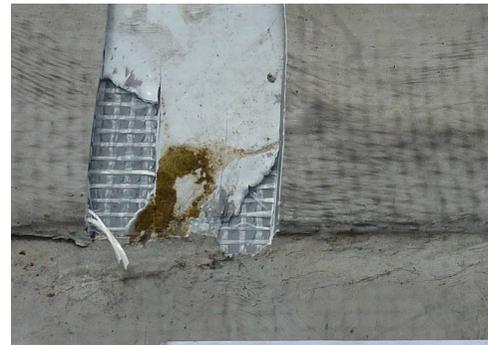
Interrupted automatic weld caused by carbon deposits from the welding nozzle.

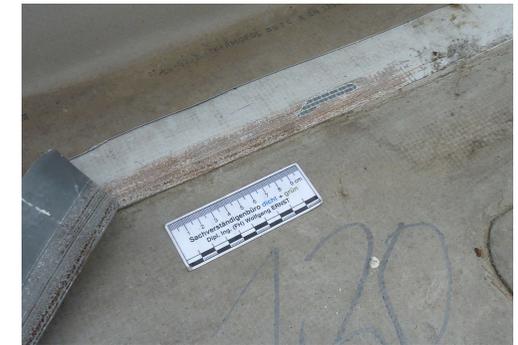
Faulty automatic weld caused by incorrect welding temperature or welding speed.

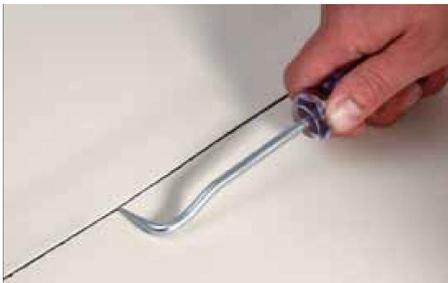
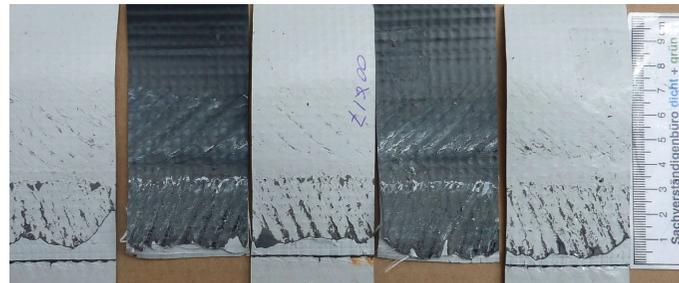
only a few mm homogeneous of 20 mm minimum standard

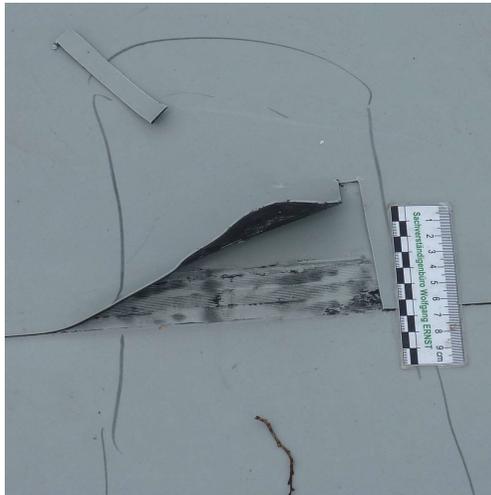
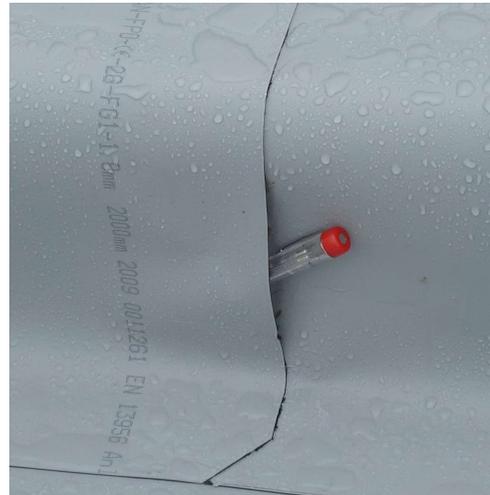
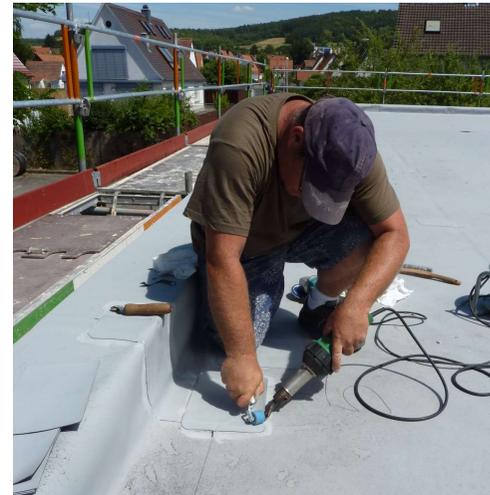
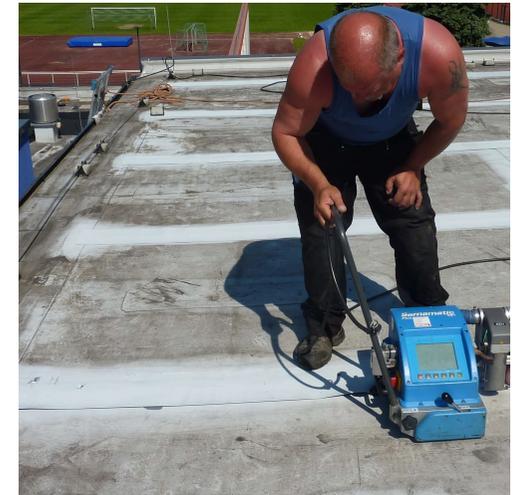
Non-homogeneously welded seams will come open after a few years.

Glued seams have welding beads, which is why a test needle will not work.

Start of coming loose.

Open seam after only a few years of exposure time. The roof becomes leaky.

Any faulty seam welds found during quality testing/acceptance testing needs to be overlap-welded.

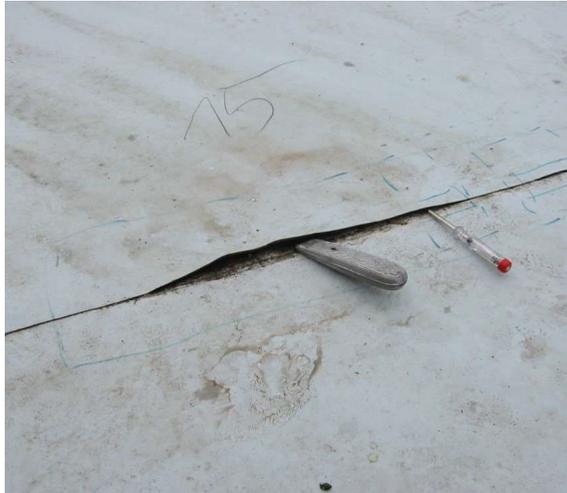
Examples of open seams after 13 and 15 years of exposure time.

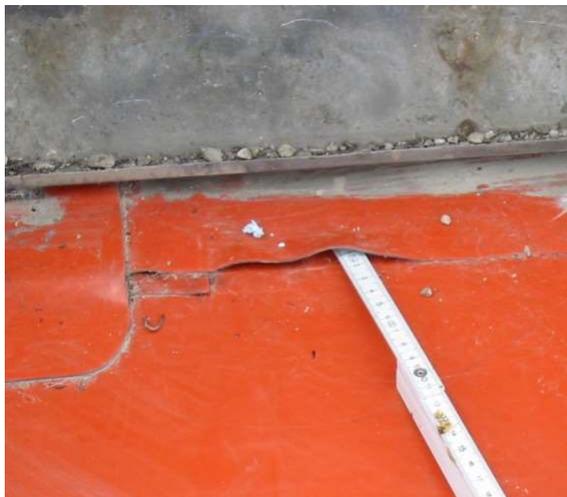
Leaky roof after 16 years of exposure time: complete refurbishment or repair?

- A) Complete refurbishment as drastic solution. Resealing with bituminous sheeting. Decision made by an inexperienced architect, without the benefit of an inventory analysis. Construction costs: **€ 540.000,00**
- B) Resource-conserving overhaul of the existing waterproofing. Recommendation by an expert with many years of experience, following an inventory analysis and functional forecast (see following page). Construction costs: **€ 225.000,00**

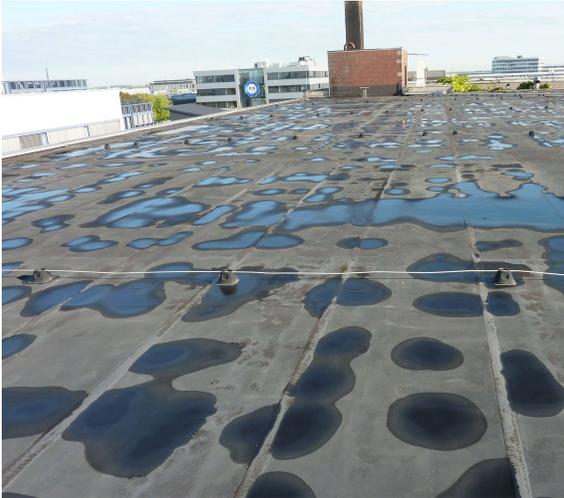
Example of:
PVC-membrane, thickness 1.5 mm,
with temporary water ponding.

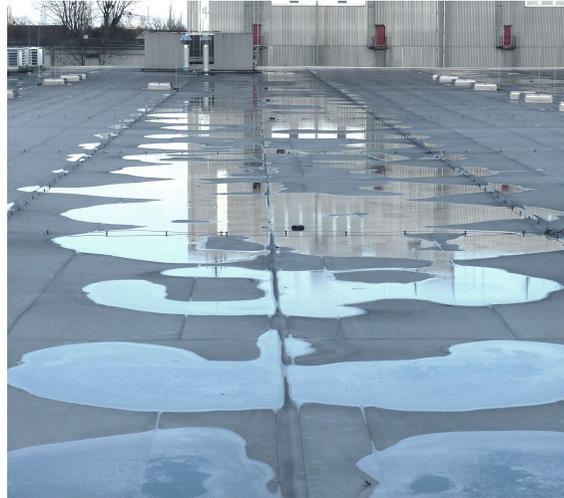
Example of:
TPO-membrane, thickness 1.8 mm,
with temporary water ponding.

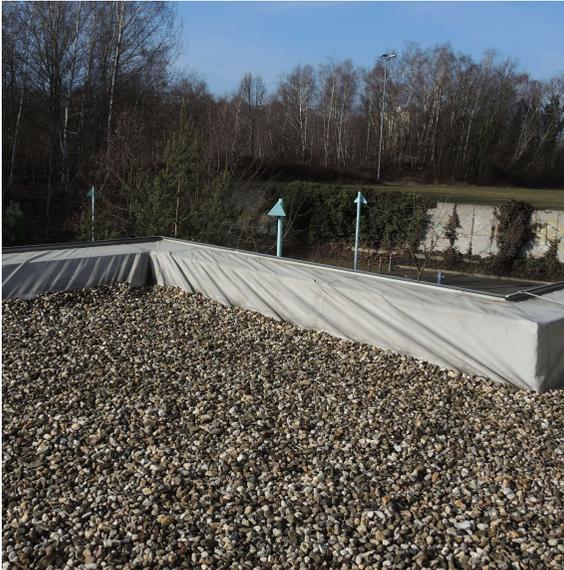
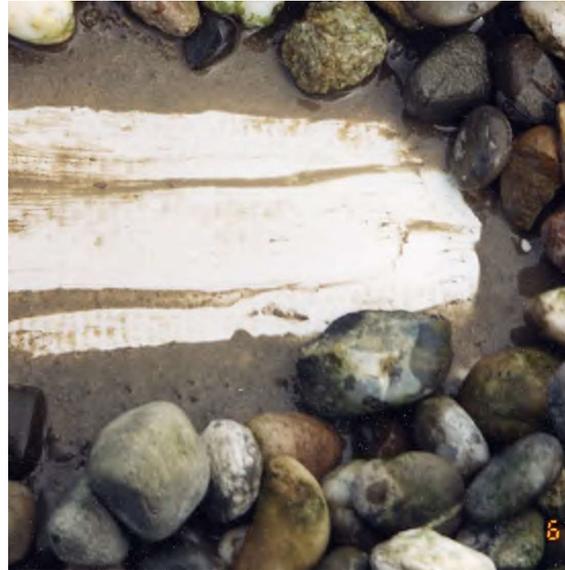
Reduction in life time caused by unsuitable gravel load

Gravel roofs without an additional protective layer (PE membrane) on the waterproofing layer show accelerated ageing behavior. The dirt deposits accumulating on the waterproofing layer are an ideal breeding ground e.g. for microorganisms.

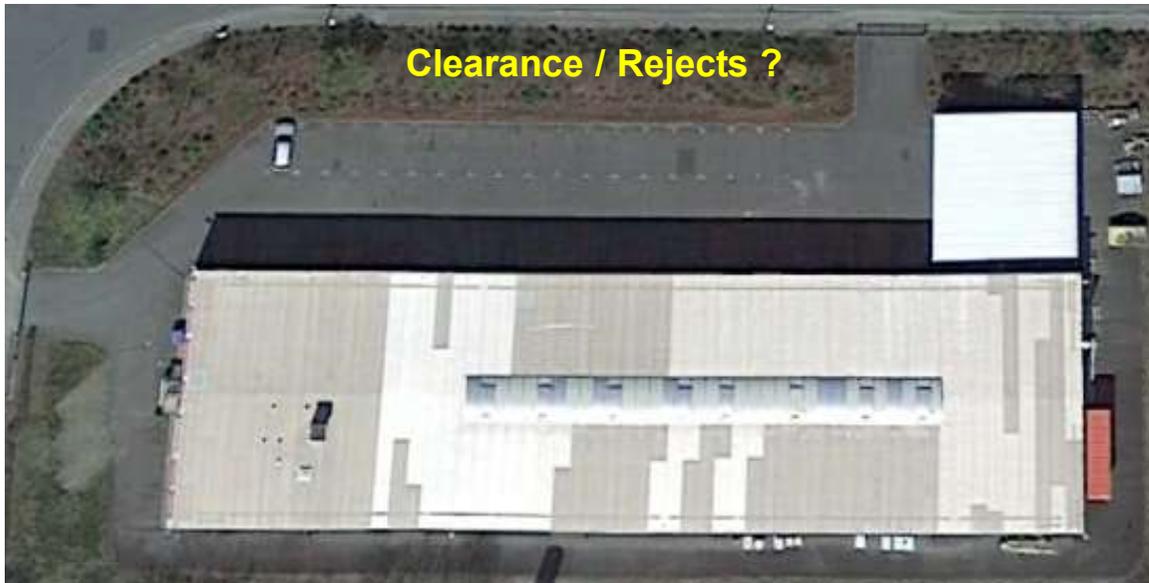
Roof surface featuring two different TPO membranes of 1.8 mm thickness by a single manufacturer:

In comparison to the reference sample from the 2008 production, significant changes in material properties were found after approximately 8.5 years of exposure time, as clearly evident from the functional life diagram.
