Factors contributing to the life time performance of flat roofing with polymer membranes

Experience and knowledge accumulated during more than 30 years (from 1985 until 2017) of conducting analyses on more than 200 construction projects.

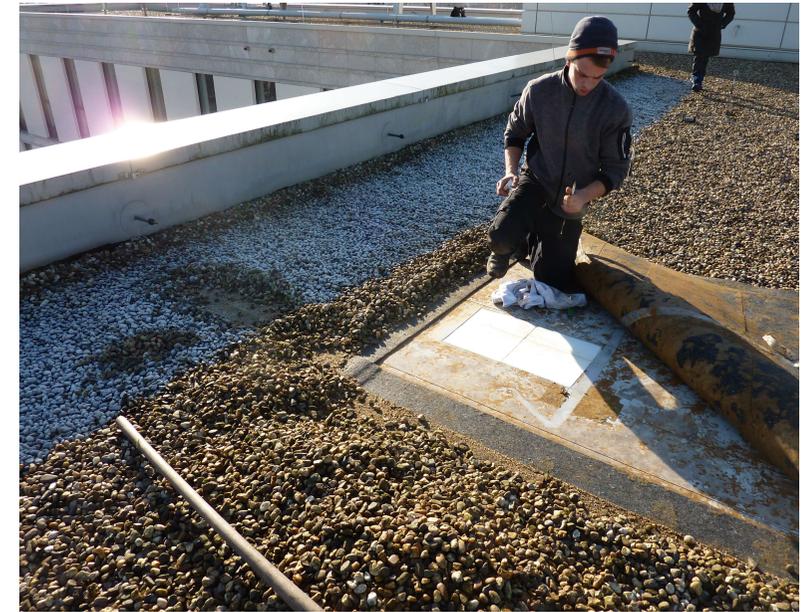
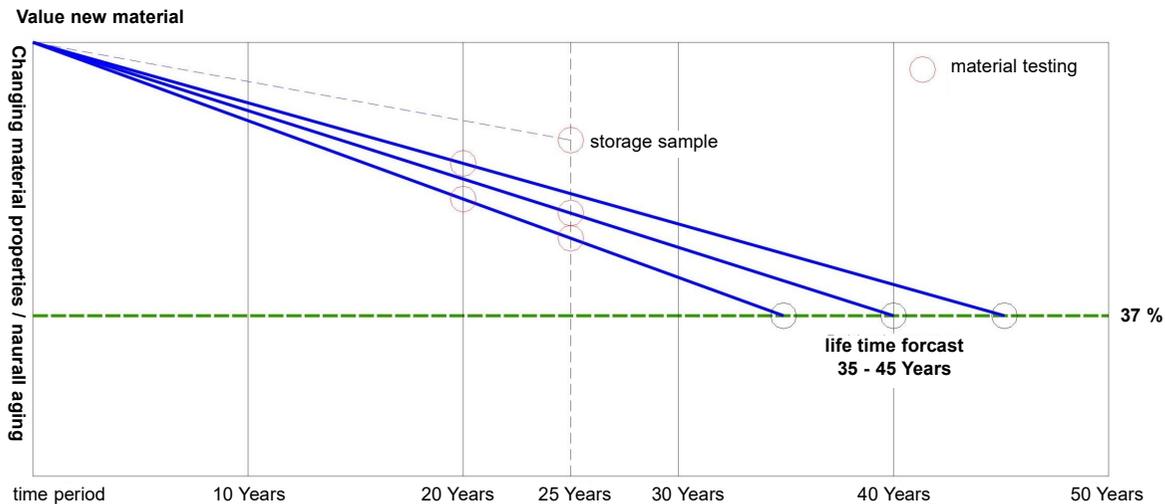
Simplified diagram for determining the (remaining) live time of a PVC membrane, thickness: 1.5 mm, loosely laid, with protective layer and gravel load, investigated on 3 building projects located in the Rhine-Maine area.

Samples were collected for laboratory testing after 20 and 25 years of exposure time, respectively. Rating of the membrane in ddD e.V. (2009): "Good".

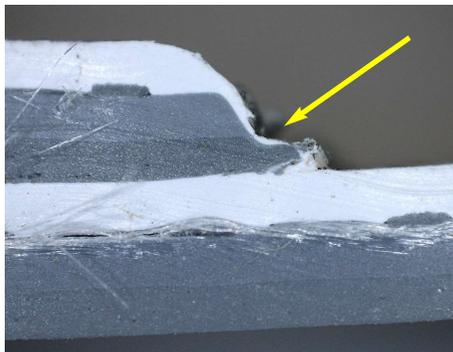
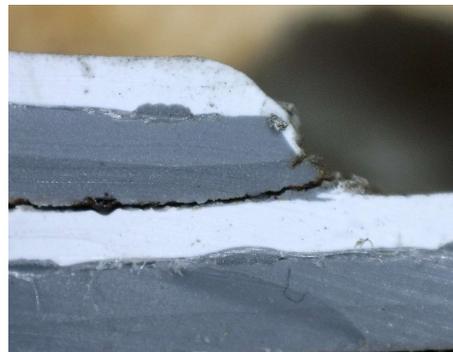
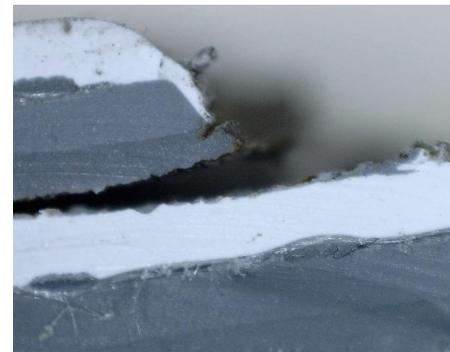
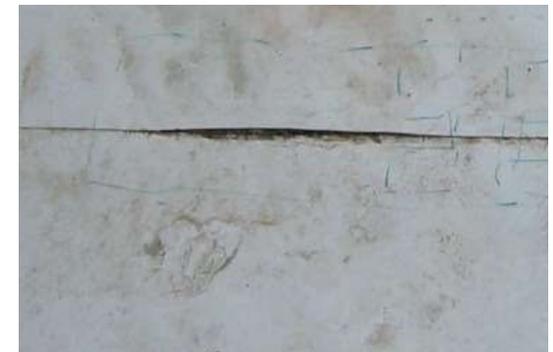
Non-homogeneously welded seams will come open after a few years.

Start of coming loose.

Open seam after only a few years of exposure time. The roof becomes leaky.

Any faulty seam welds found during quality testing/acceptance testing needs to be overlap-welded.

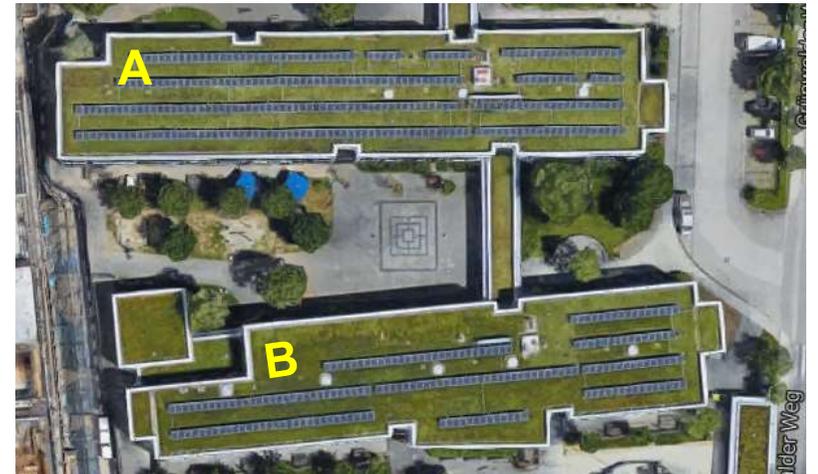
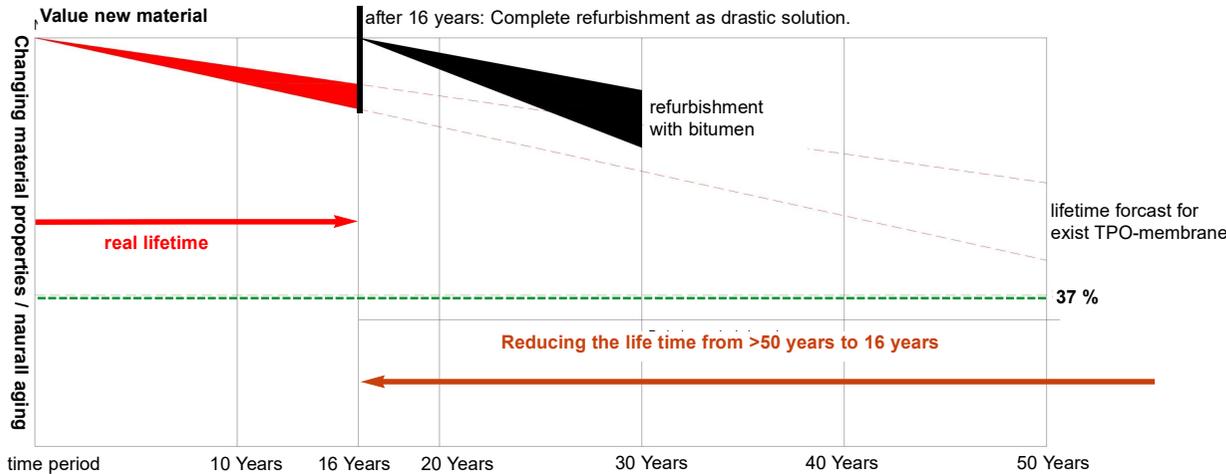
Leaky roof after 16 years of exposure time: complete refurbishment or repair?

Comparative example of two virtually identical building structures after a period of 16 years:

Architekt / Lifetime of the polymer membrane: **16 Years**

Expert / Lifetime of the polymer membrane: **>50 Jahre**

- A) Complete refurbishment as drastic solution. Resealing with bituminous sheeting. Decision made by an inexperienced architect, without the benefit of an inventory analysis. Construction costs: **€ 540.000,00**
- B) Resource-conserving overhaul of the existing waterproofing. Recommendation by an expert with many years of experience, following an inventory analysis and functional forecast (see following page). Construction costs: **€ 225.000,00**

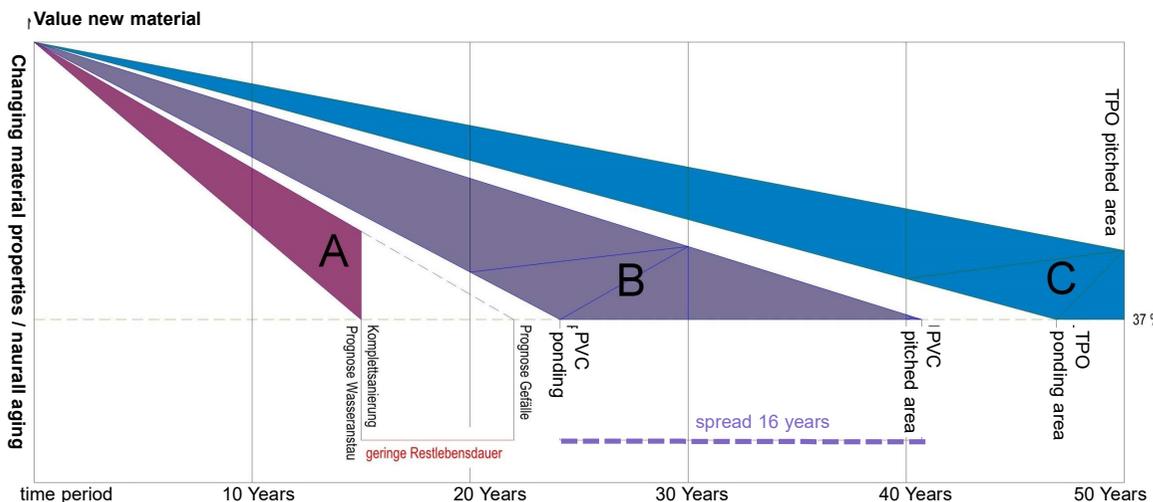
Comparative examples for differences between the different materials groups when exposed to roof pitch and water ponding:

A) Membrane with PVC share, 1.2 mm thickness, material failure in the water ponding area, complete refurbishment due to short remaining life.

B) PVC membrane, 1.5 mm thickness, significantly reduced life time as a result of accelerated ageing behavior.

C) FPO/TPO membrane, 1.8 mm thickness,

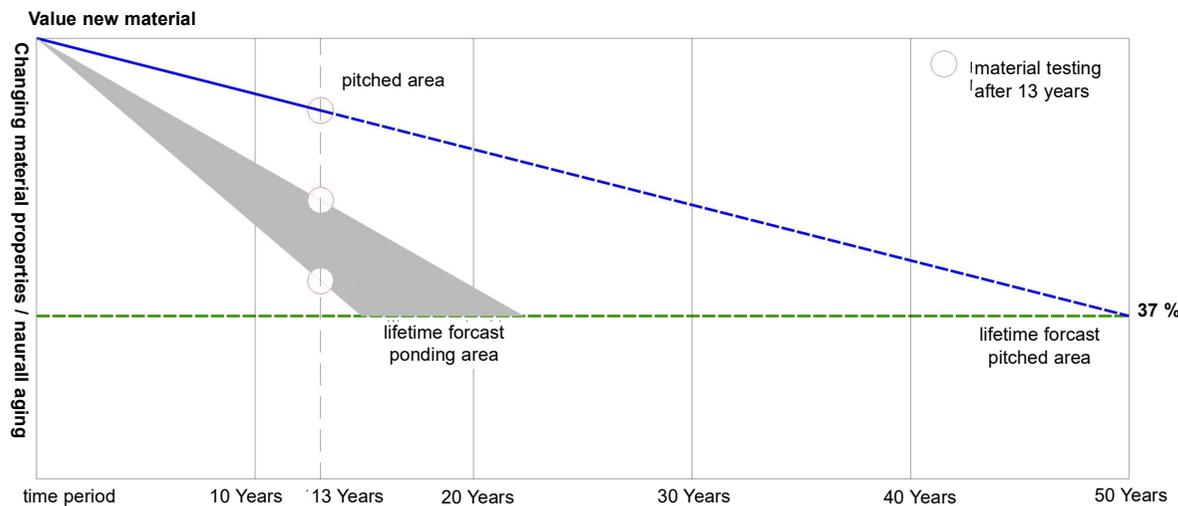
Example of partial refurbishment of the roof edge

Thanks to the positive material properties of the PVC membrane in the pitched area, with an appropriate service life forecast, an approximately 2 meter wide strip was refurbished along the roof parapet after 13 years exposure time (approx. **10% of the total surface**).

Thanks to the adequate height of the roof parapet, it was possible, with the aid of insulating wedges, to create a 2% cross slope to the run-offs in the roof parapet valley. After cleaning the seams, it was possible to weld the old membrane material to the new membrane material without any problems.

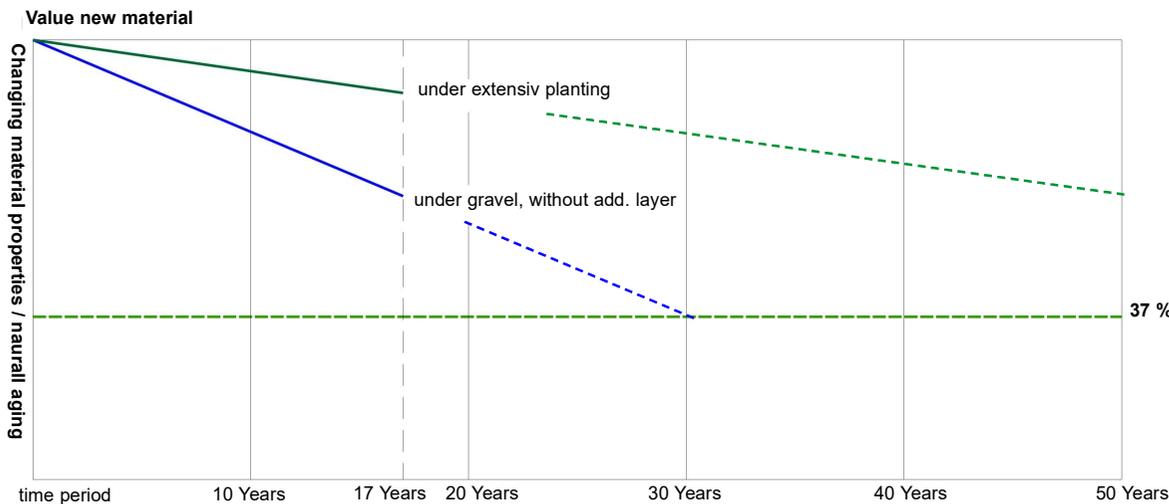
Gravel roofs without an additional protective layer (PE membrane) on the waterproofing layer show accelerated ageing behavior. The dirt deposits accumulating on the waterproofing layer are an ideal breeding ground e.g. for microorganisms.

Life time forecast for an PVC roof sheeting membrane, 2.0 mm thickness, E: GV, loosely laid, either under extensive roof planting or under gravel (material analysis after 17 years of exposure time).

From the point of view of overall roof life time with polymer membranes, the negligible extra costs for a protective extensive planting system are never wasted.

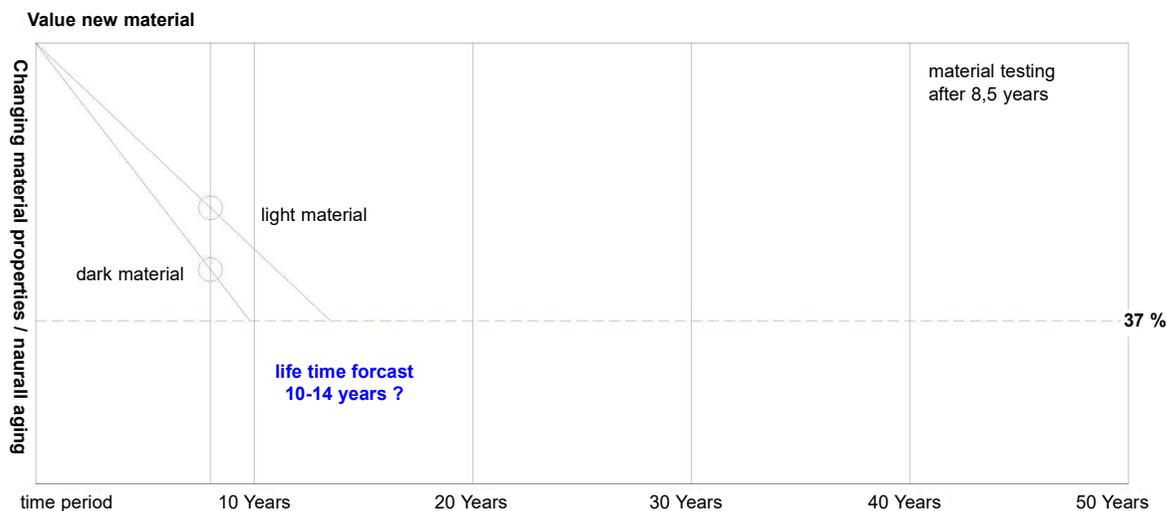
Roof surface featuring two different TPO membranes of 1.8 mm thickness by a single manufacturer:

In comparison to the reference sample from the 2008 production, significant changes in material properties were found after approximately 8.5 years of exposure time, as clearly evident from the functional life diagram.

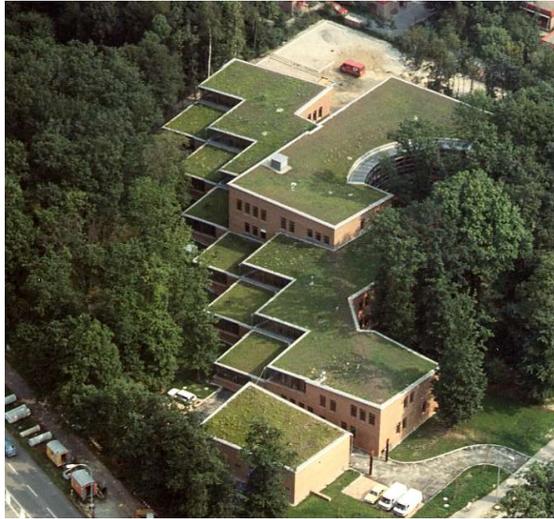
Object example, year of construction **1987**, (now 30 Years), PVC-membrane, thickness: 2,4 mm,

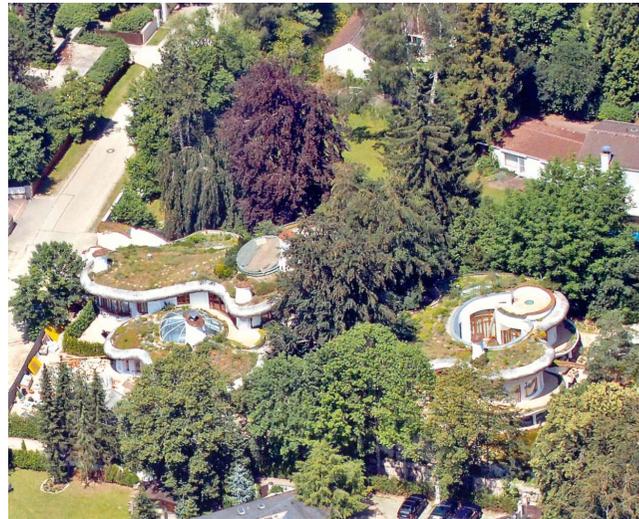
Object example, year of construction **1989** (now 28 Years) PVC-membrane, thickness: 2,0 mm, (both PVC-membranes from the same manufacturer).
